# BNSF Railway

## 2011 Flood Remediation Efforts

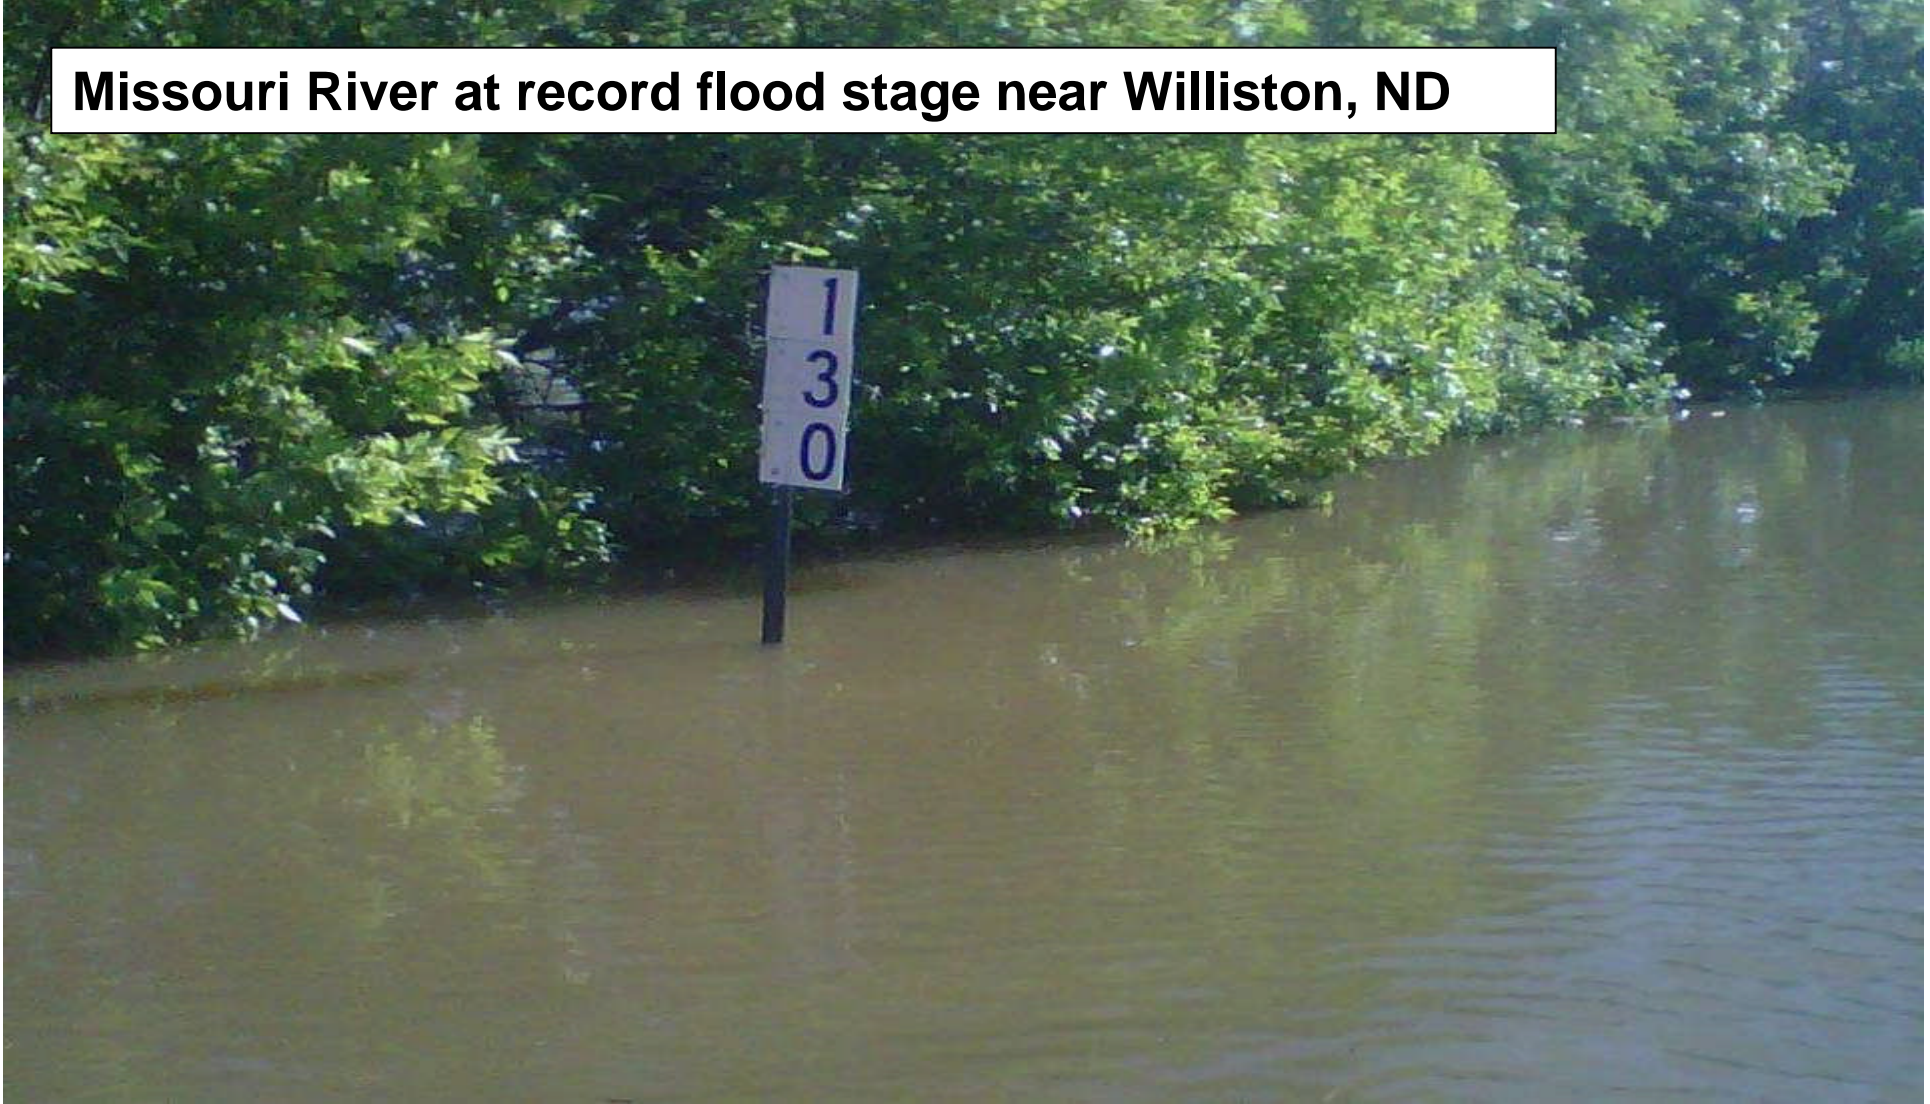
# Montana Division – Glasgow Subdivision

Missouri River at record flood stage near Williston, ND

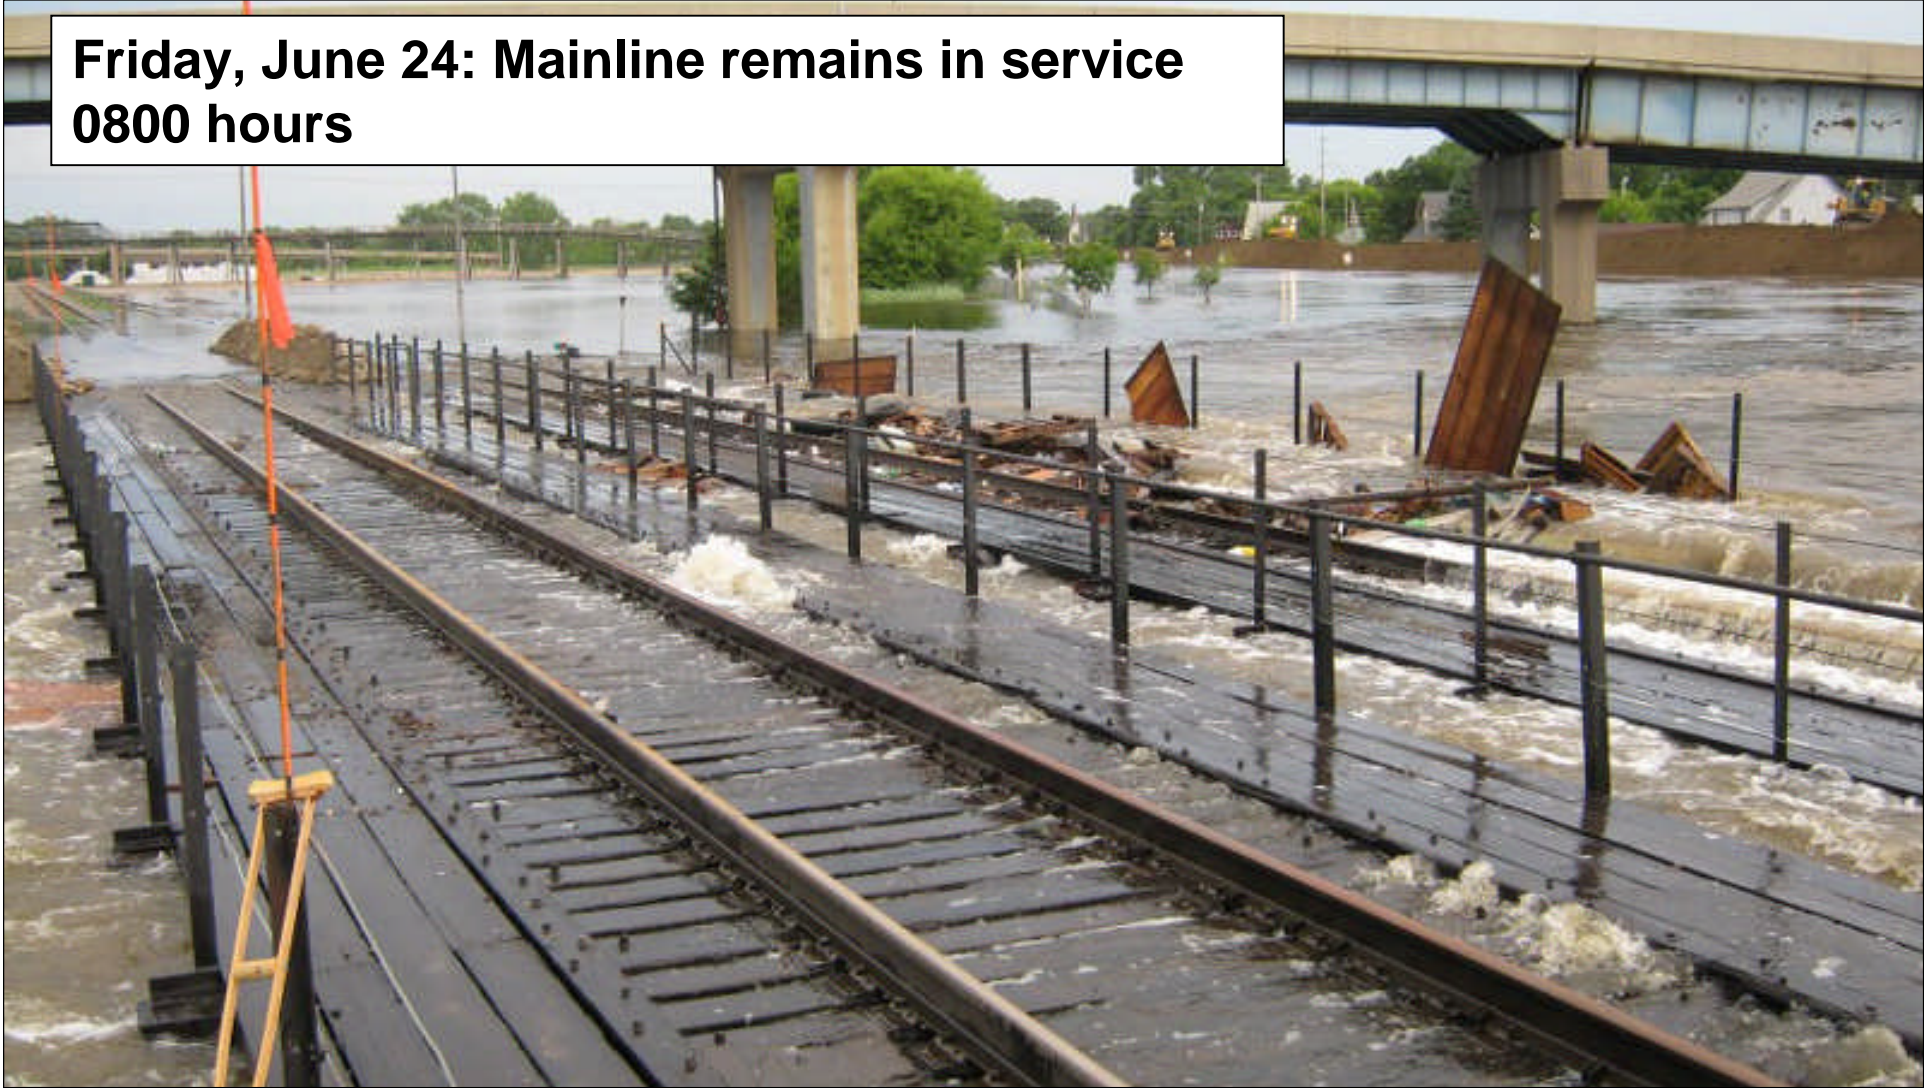
# Montana Division – Minot, ND

Friday, June 24: Mainline remains in service  
0800 hours

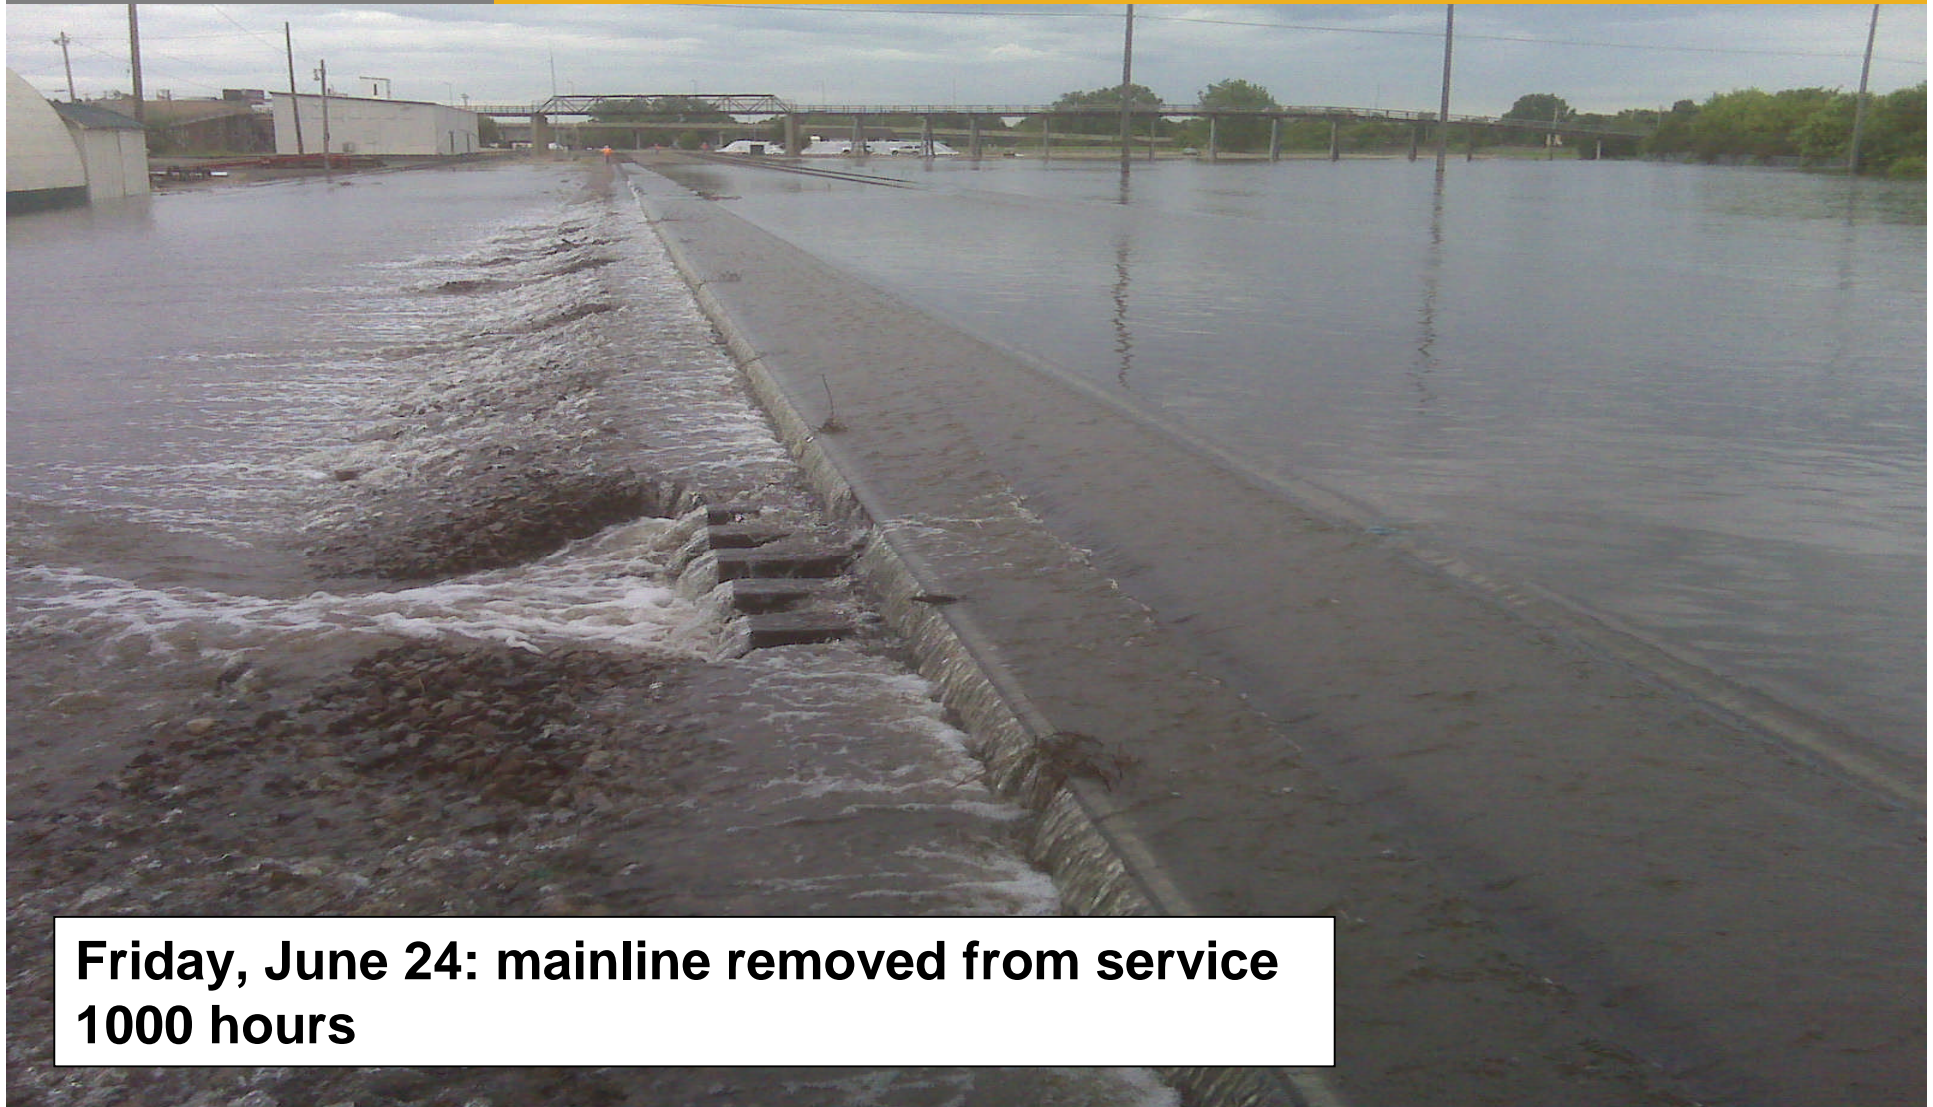
# Montana Division – Minot, ND

**Friday, June 24: mainline removed from service  
1000 hours**

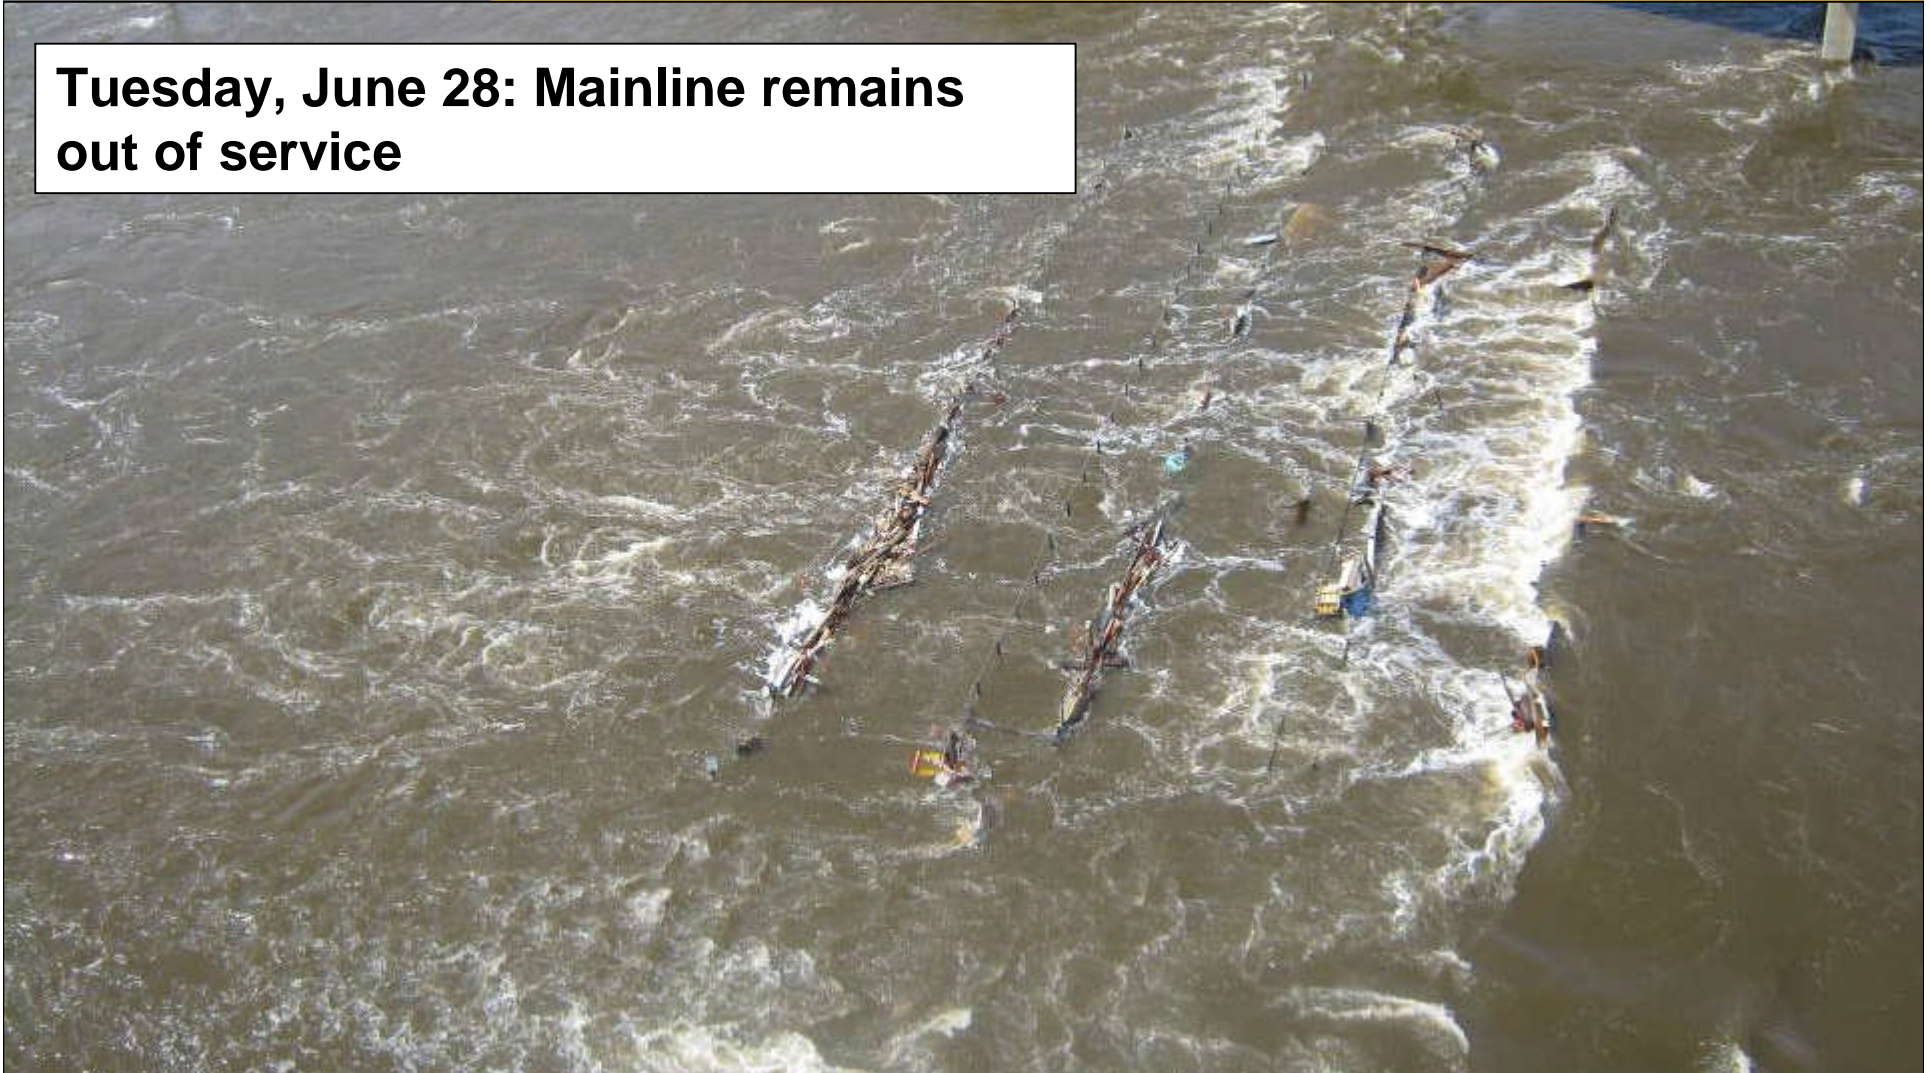
# Montana Division – Minot, ND

Tuesday, June 28: Mainline remains out of service

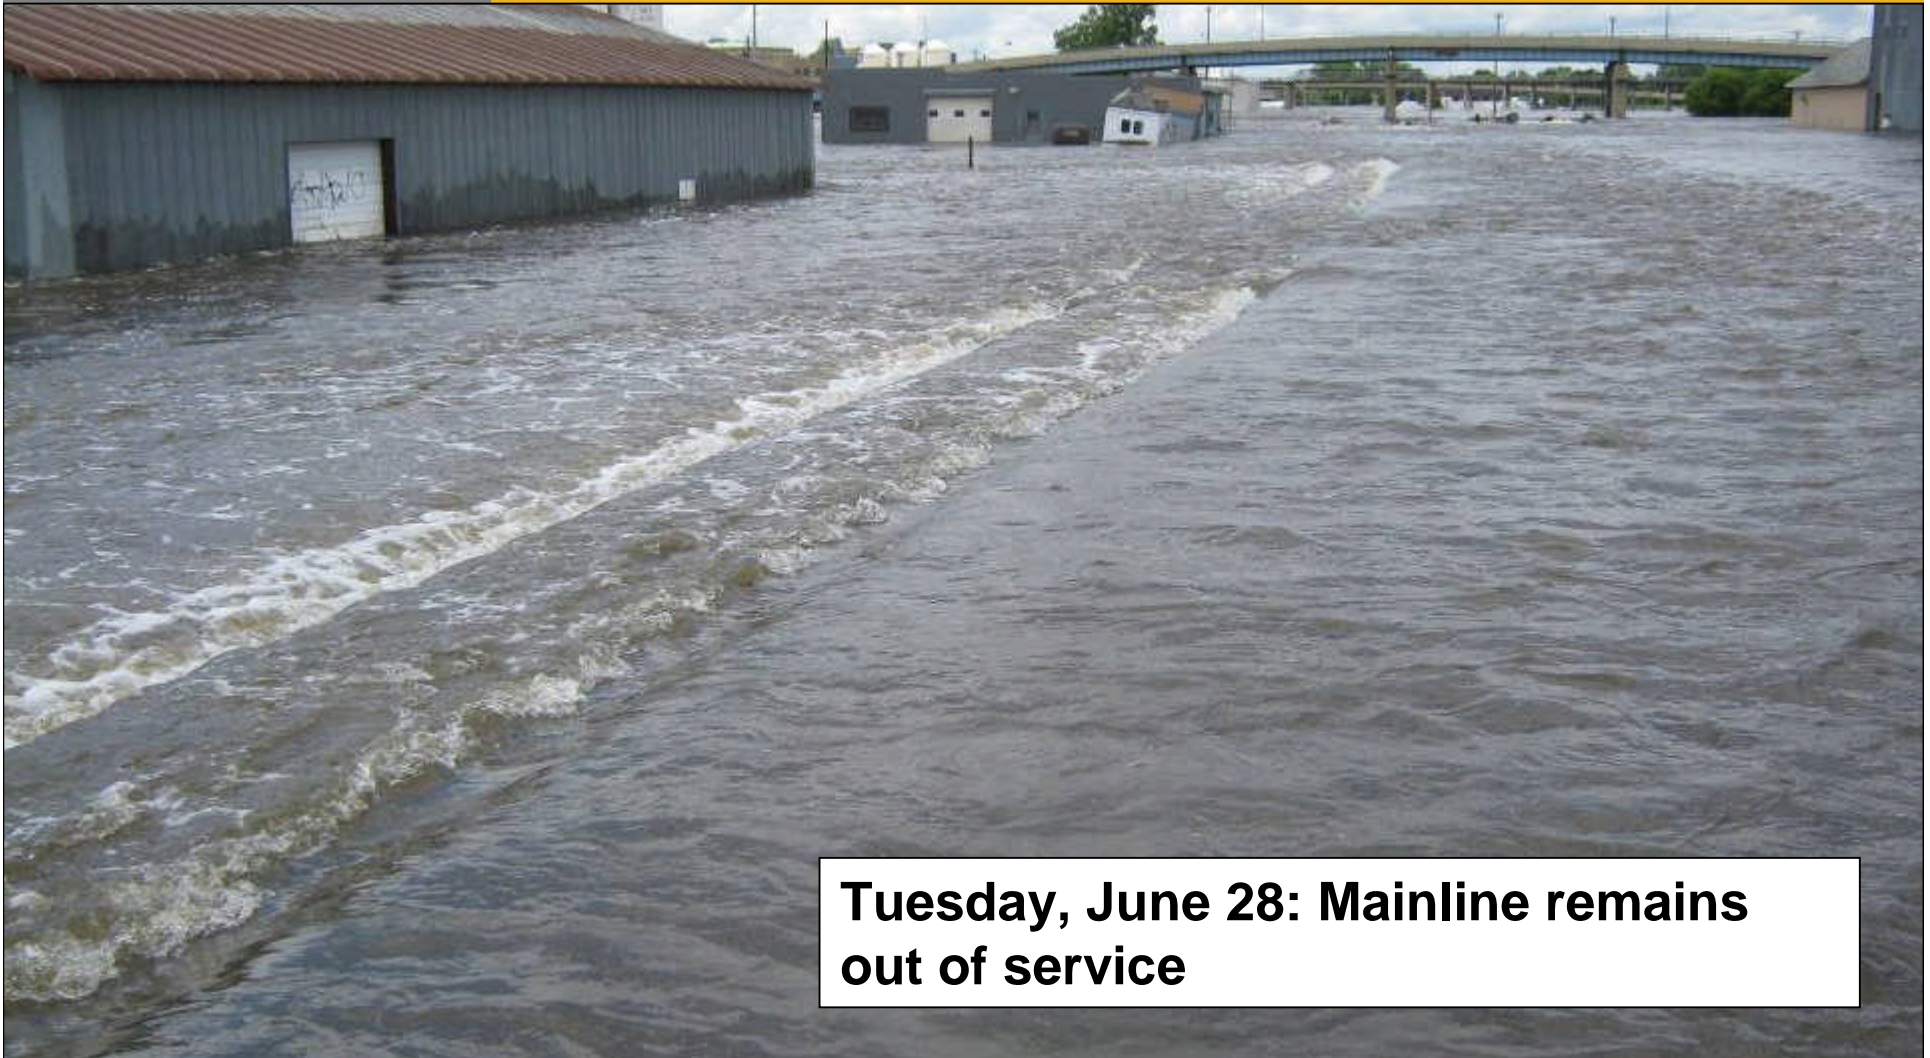
# Montana Division – Minot, ND

**Tuesday, June 28: Mainline remains out of service**

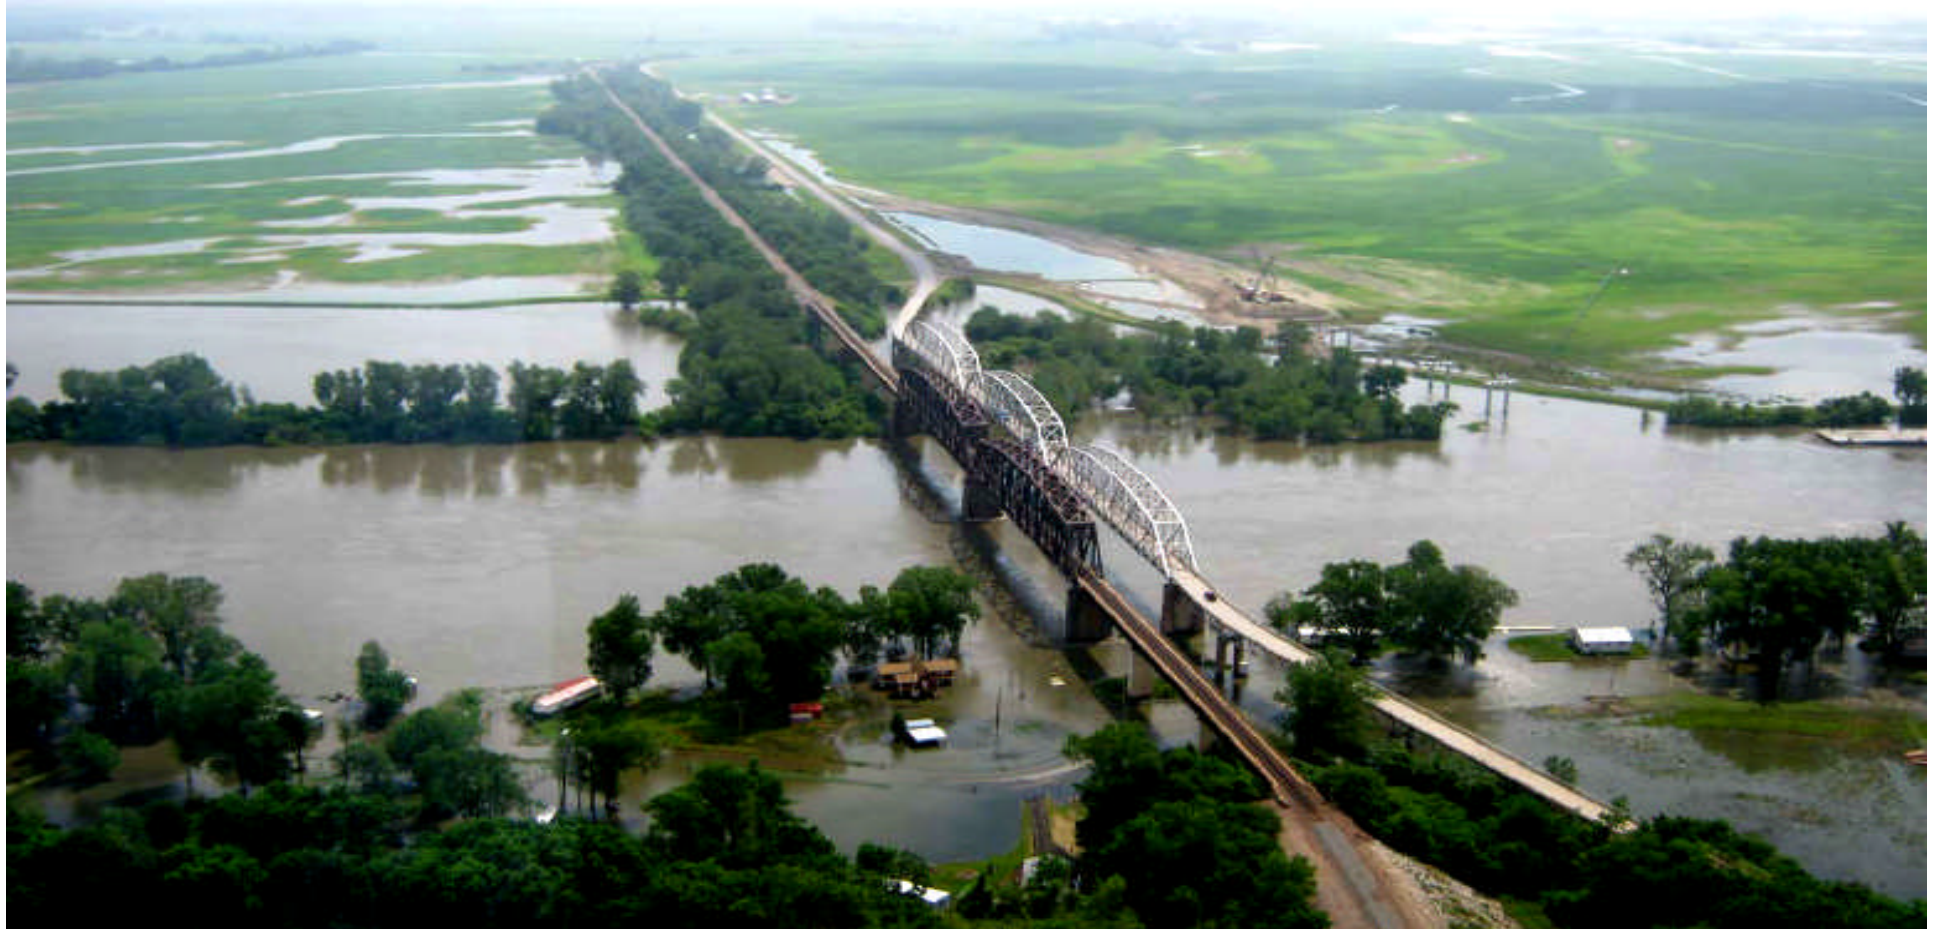
# Nebraska Division – St. Joseph Subdivision

Rulo, NE river bridge June 10, 1030 hours

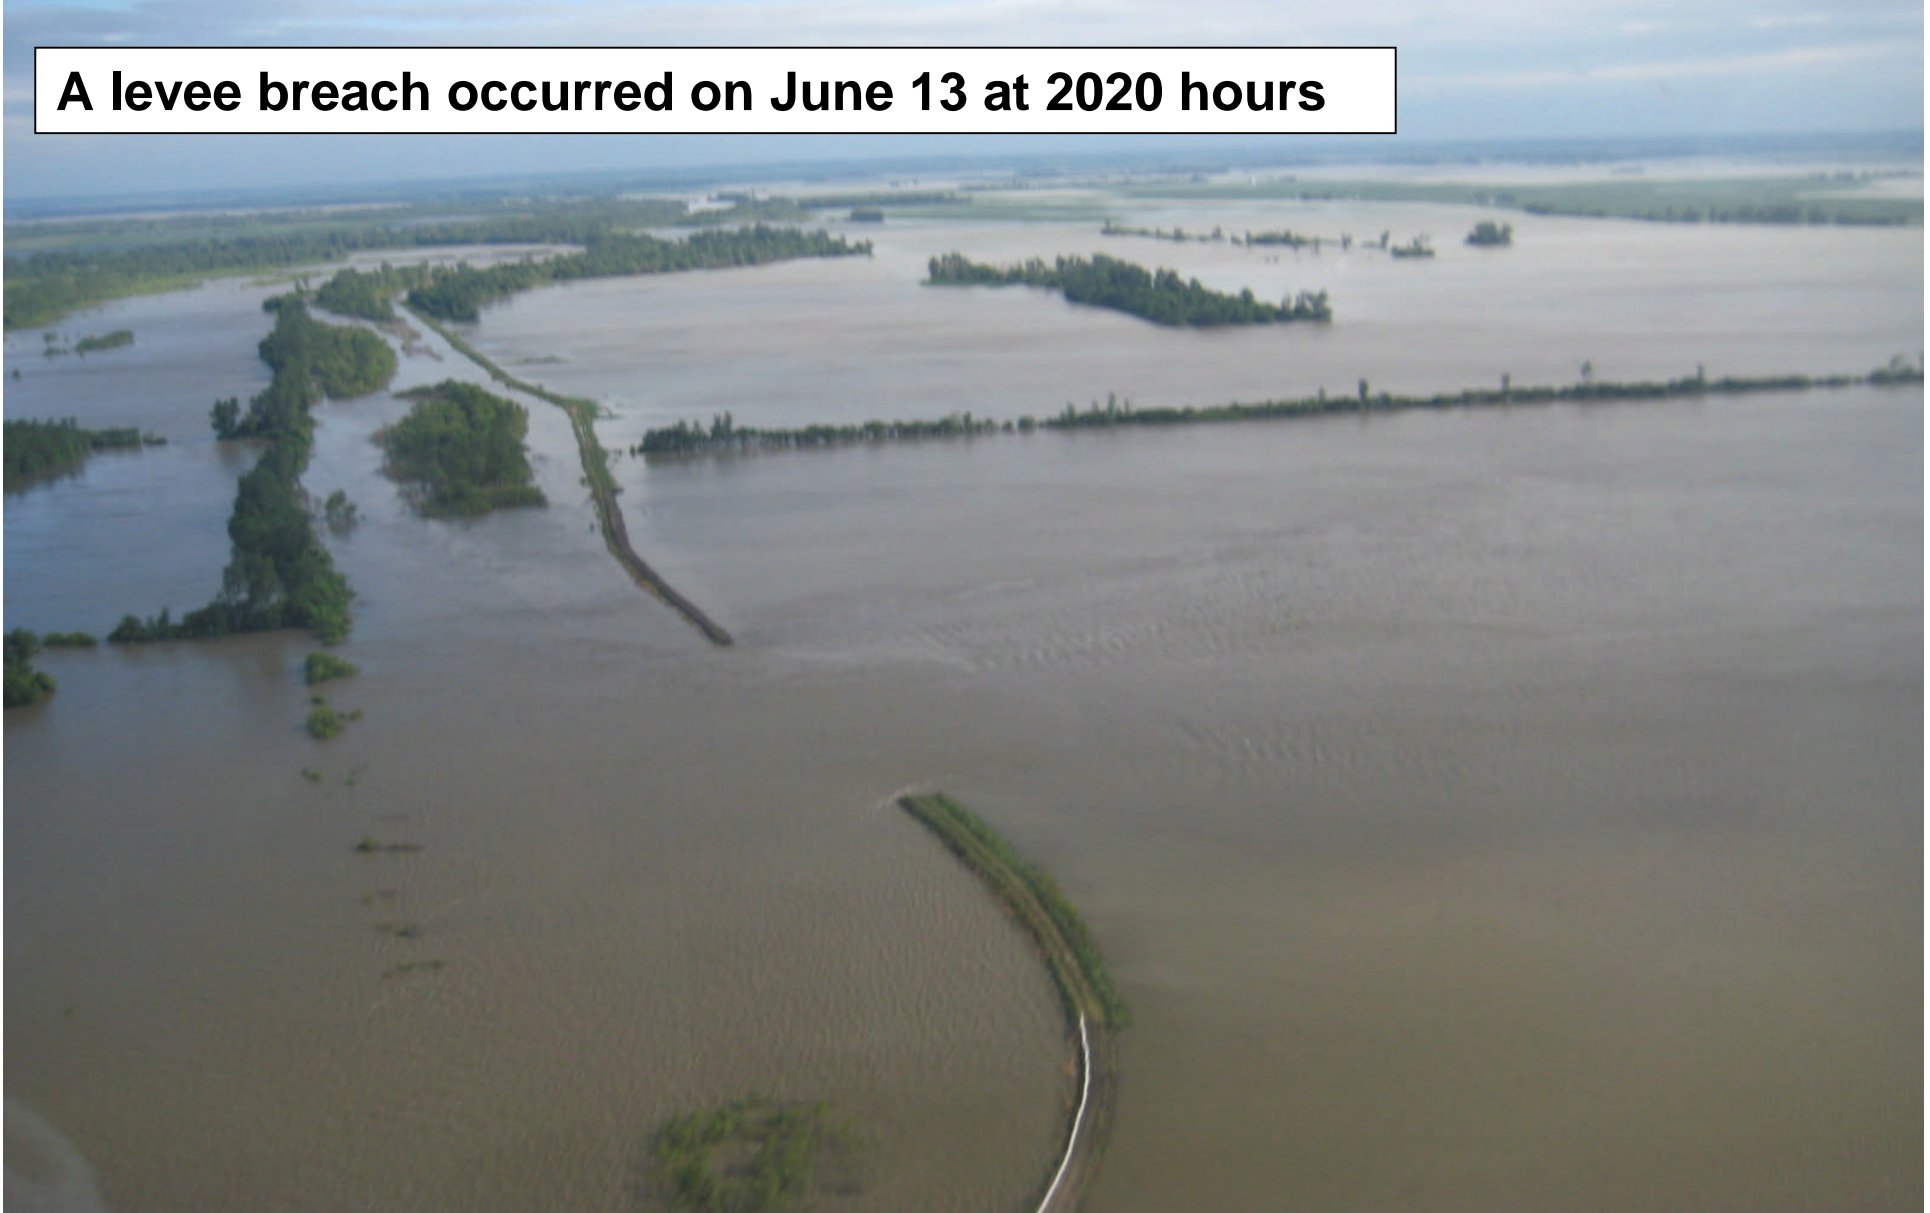
# Nebraska Division – St. Joseph Subdivision

A levee breach occurred on June 13 at 2020 hours

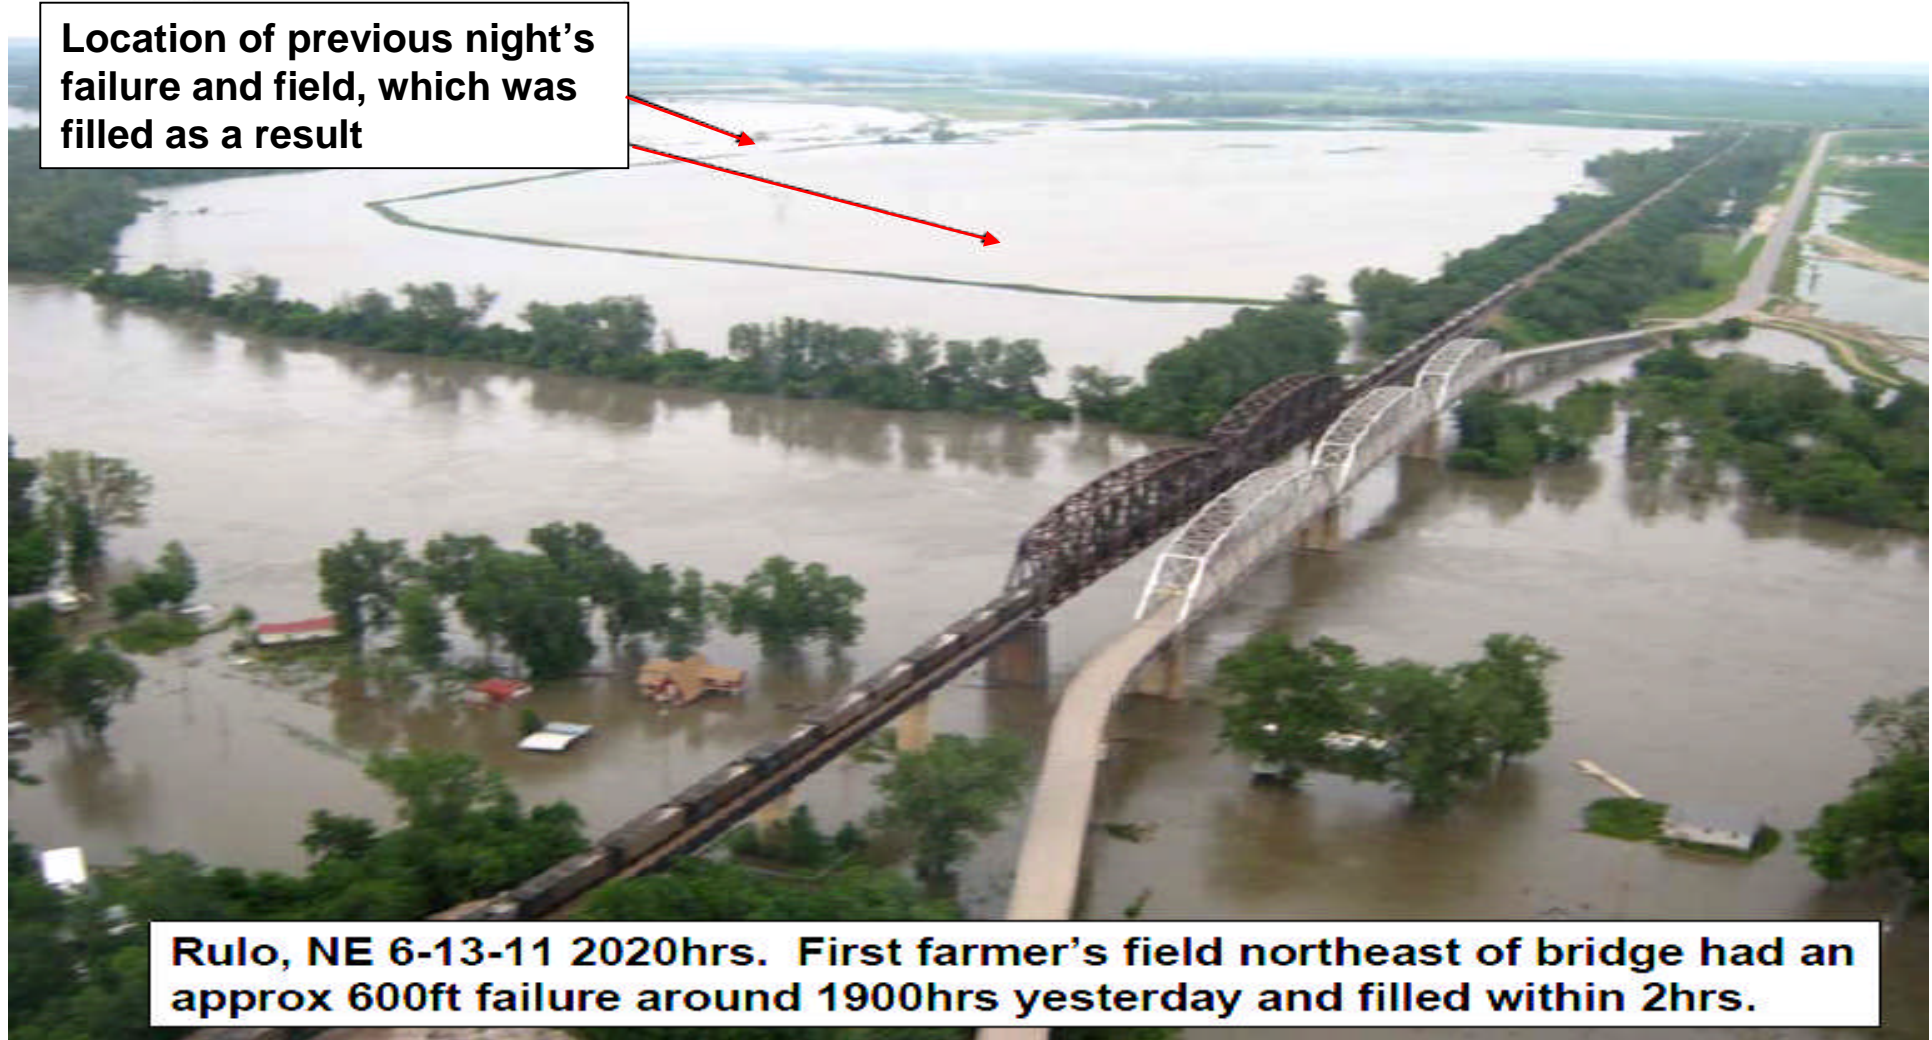
# Nebraska Division – St. Joseph Subdivision

Location of previous night's failure and field, which was filled as a result

Rulo, NE 6-13-11 2020hrs. First farmer's field northeast of bridge had an approx 600ft failure around 1900hrs yesterday and filled within 2hrs.

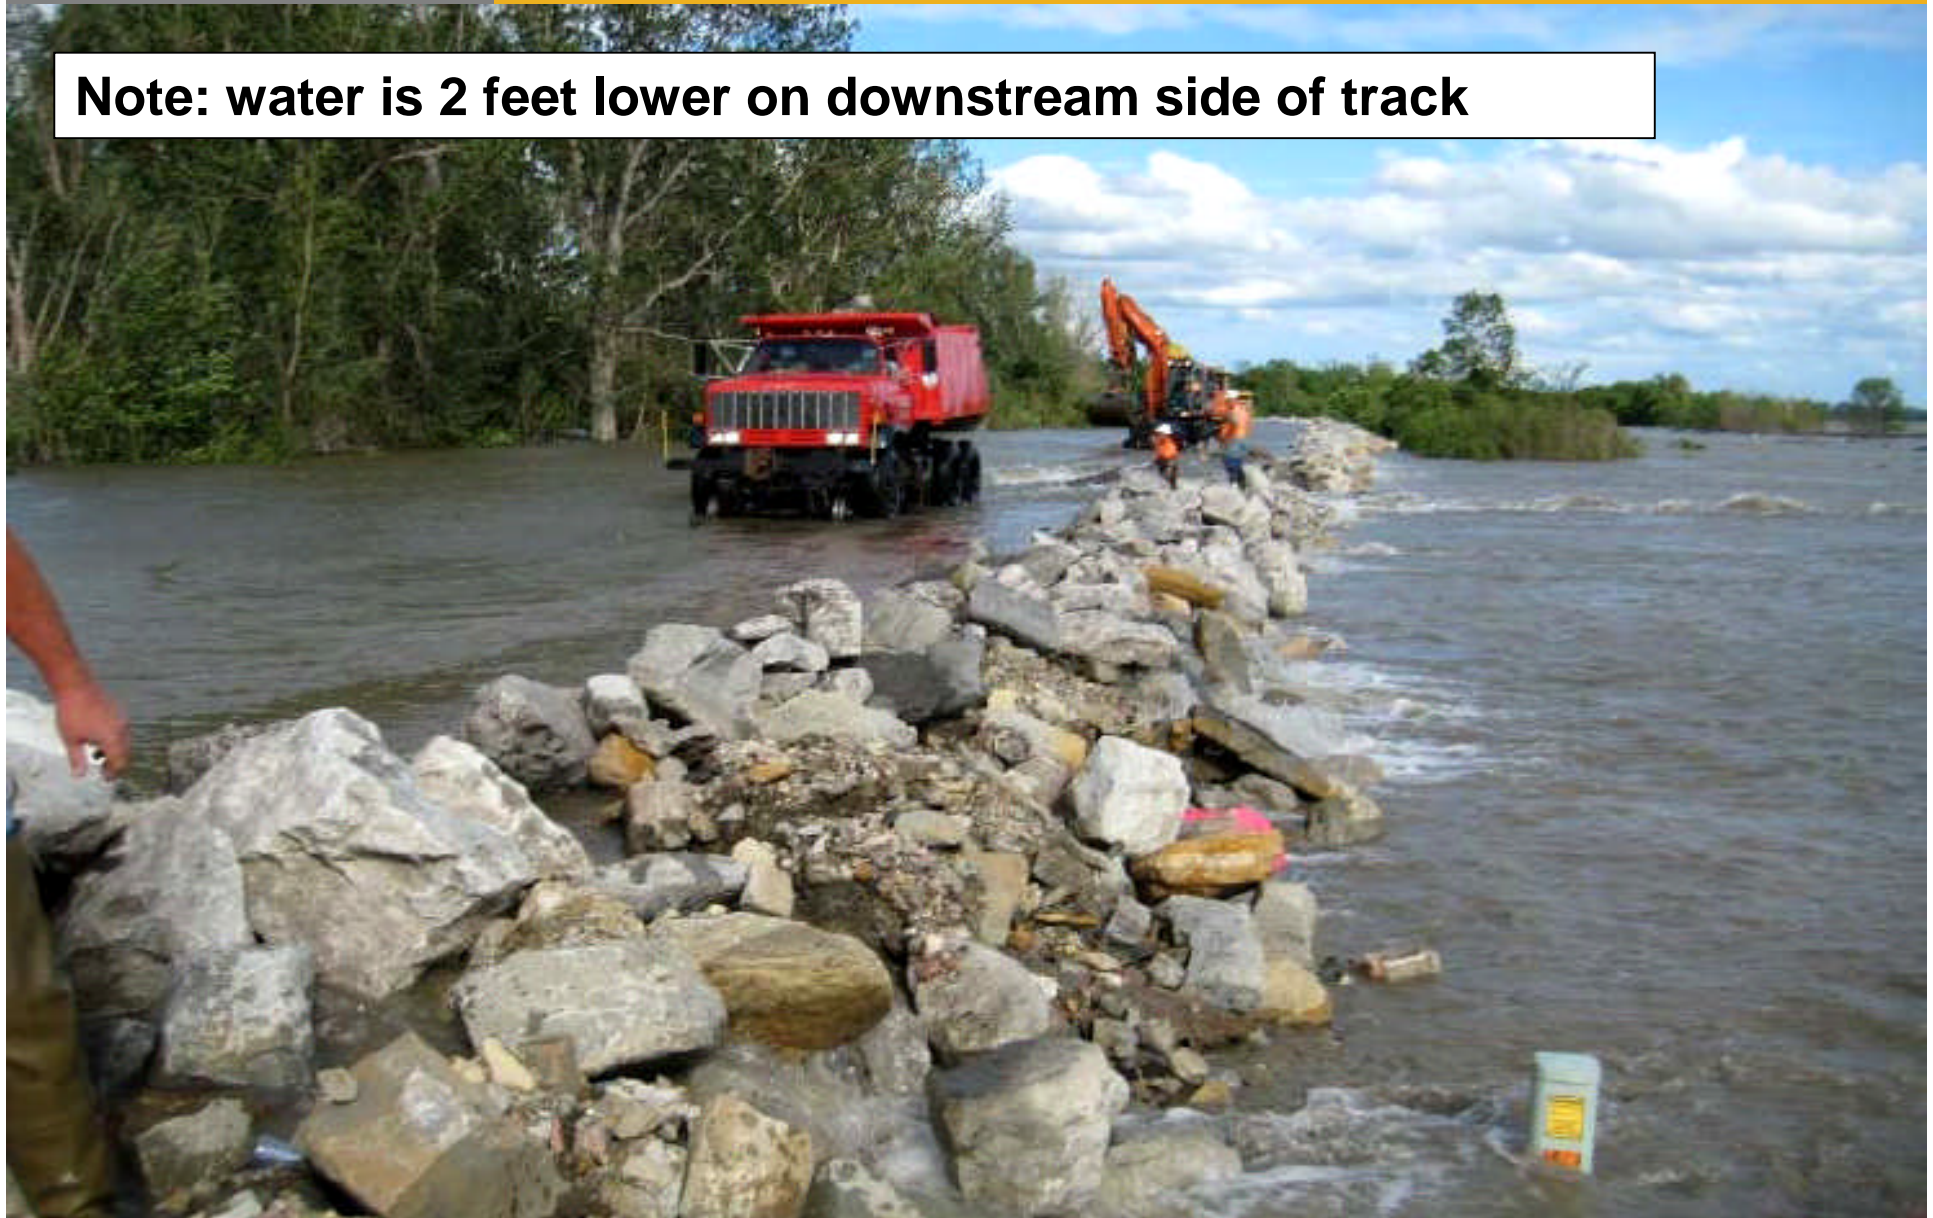
# Nebraska Division – St. Joseph Subdivision

**Note: water is 2 feet lower on downstream side of track**

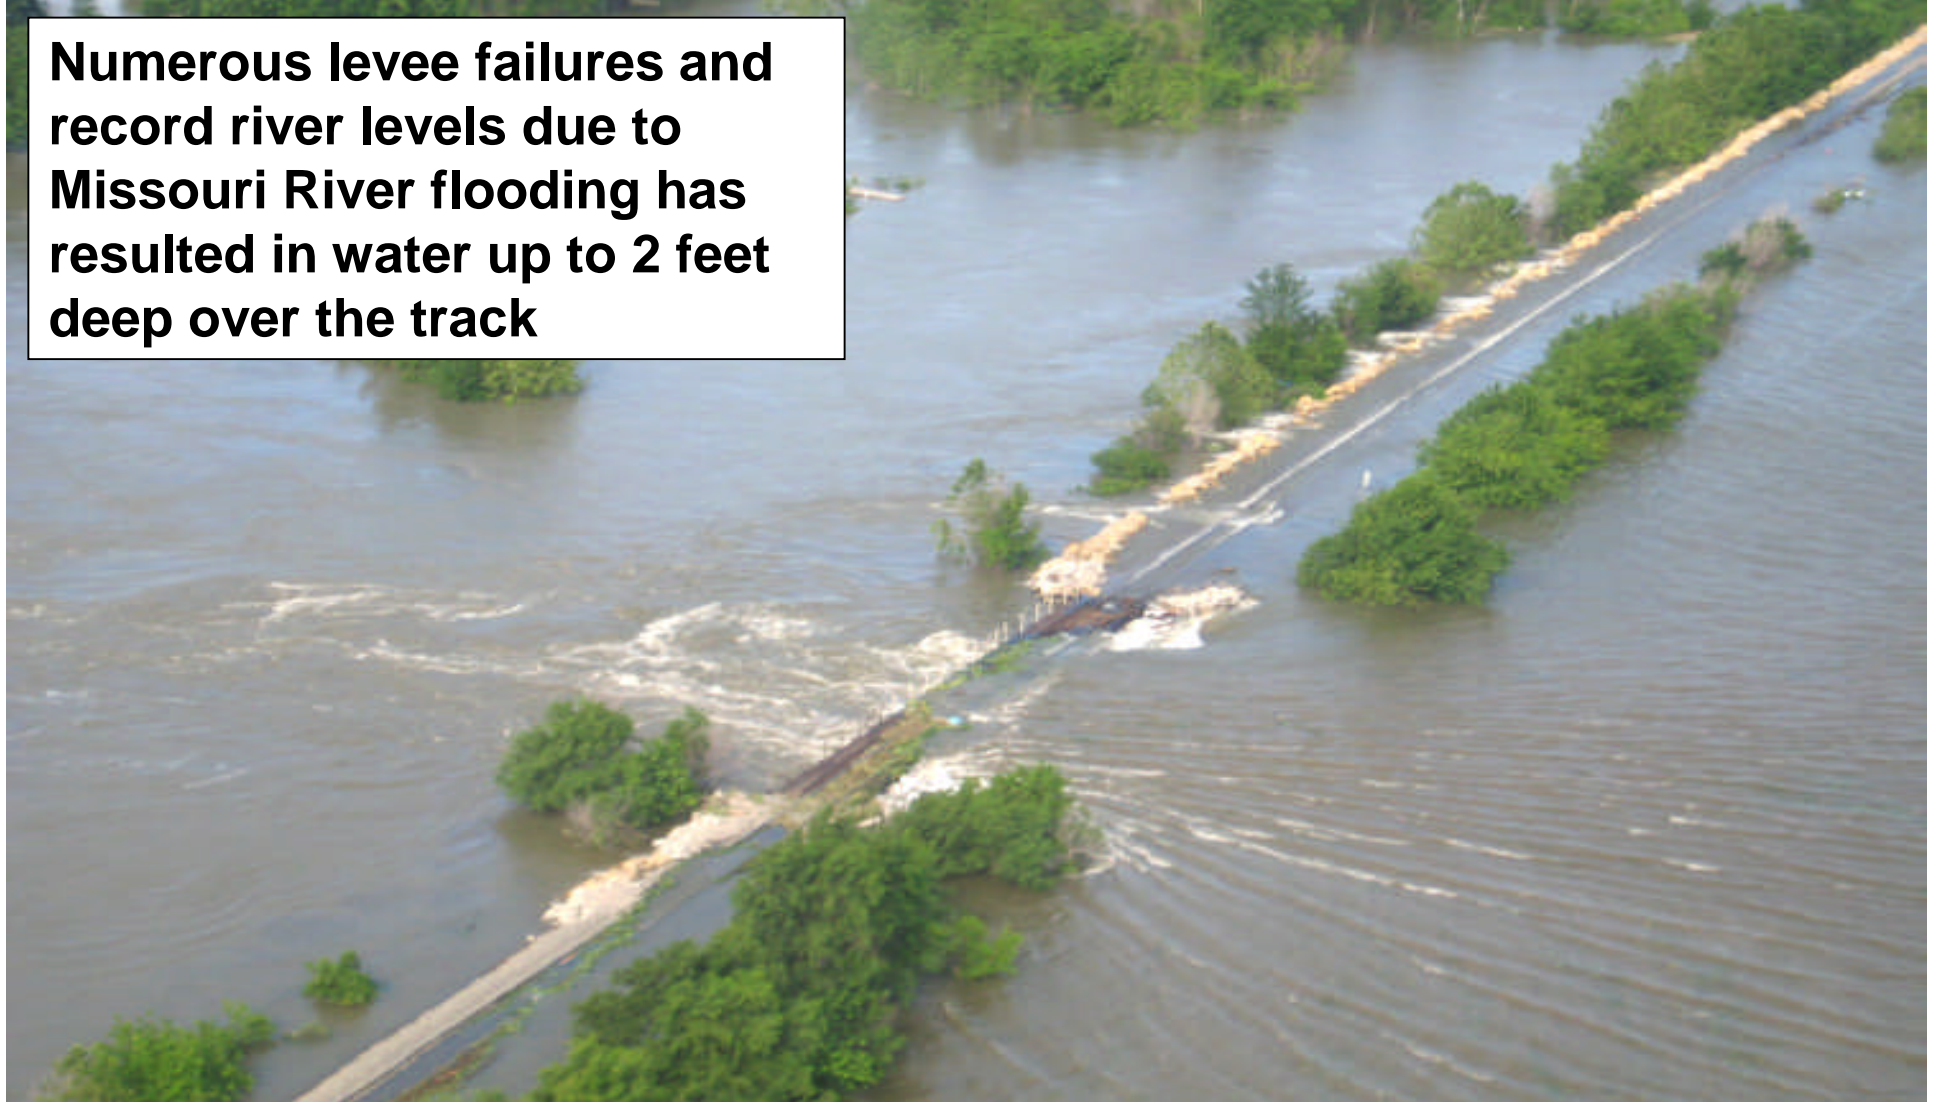
# Nebraska Division – St. Joseph Subdivision

Numerous levee failures and record river levels due to Missouri River flooding has resulted in water up to 2 feet deep over the track
